**Information Bulletin
of the Steel Industry Safety and
Health Commission**

A publication of the Commission of the European Communities

Accidents*

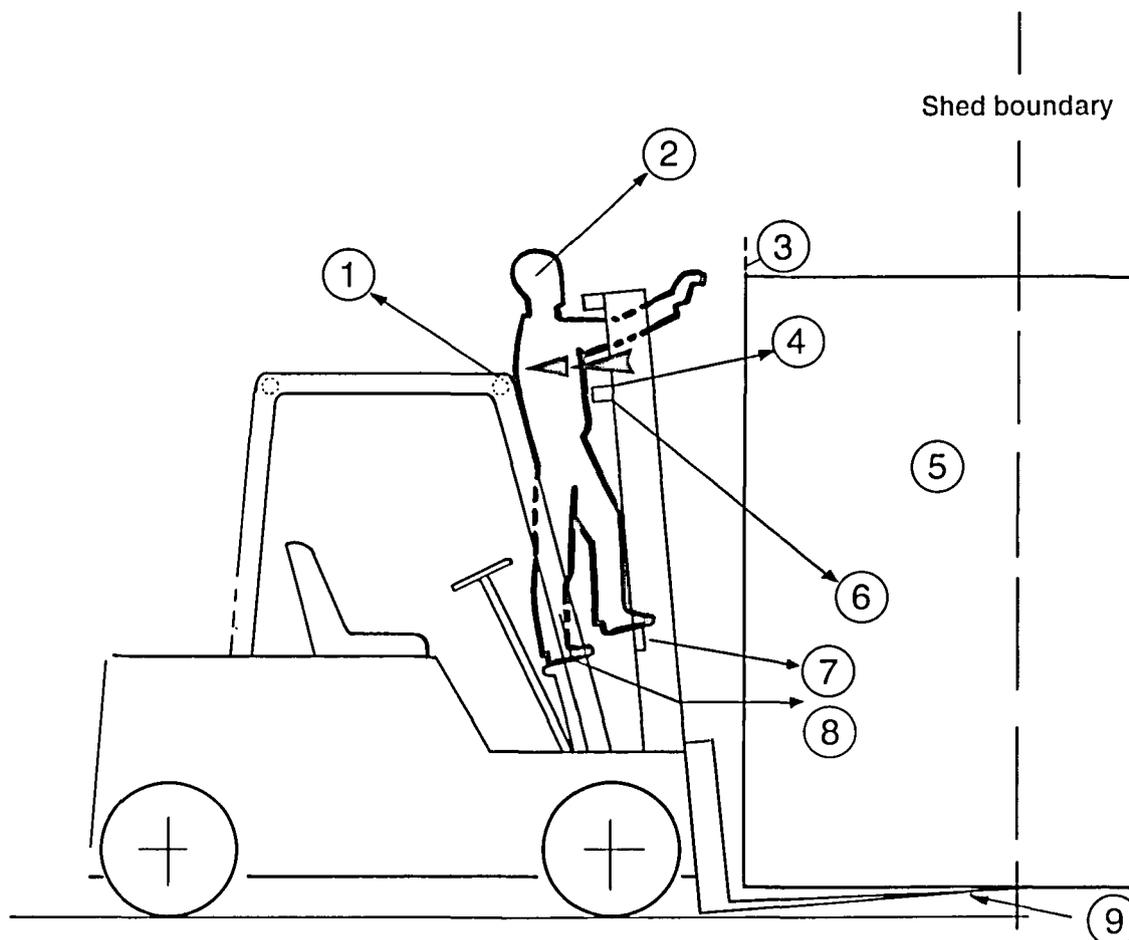
He had put one foot on a cross-bar of the mast and reached out to take hold of the rope. As he was performing this movement, or returning to his previous position, the other foot touched the control lever which caused the mast to be raised towards the roll-over bar. His thorax was thus crushed just below the heart between the bar and the mast and he died on his way to hospital.

- 1. Roll-over bar
- 2. Victim's position
- 3. Rope-attached lug welded to the cabin
- 4. Point of crushing

- 5. Cabin to be moved
- 6. Crossbar
- 7. Crossbar
- 8. Mast control lever
- 9. Forks

2. Fork-lift trucks were fitted with a windscreen (and wipers, since the trucks are also used outside the sheds) in order to ensure that if, in breach of regulations, operators do climb onto the cross bars they cannot touch the controls.

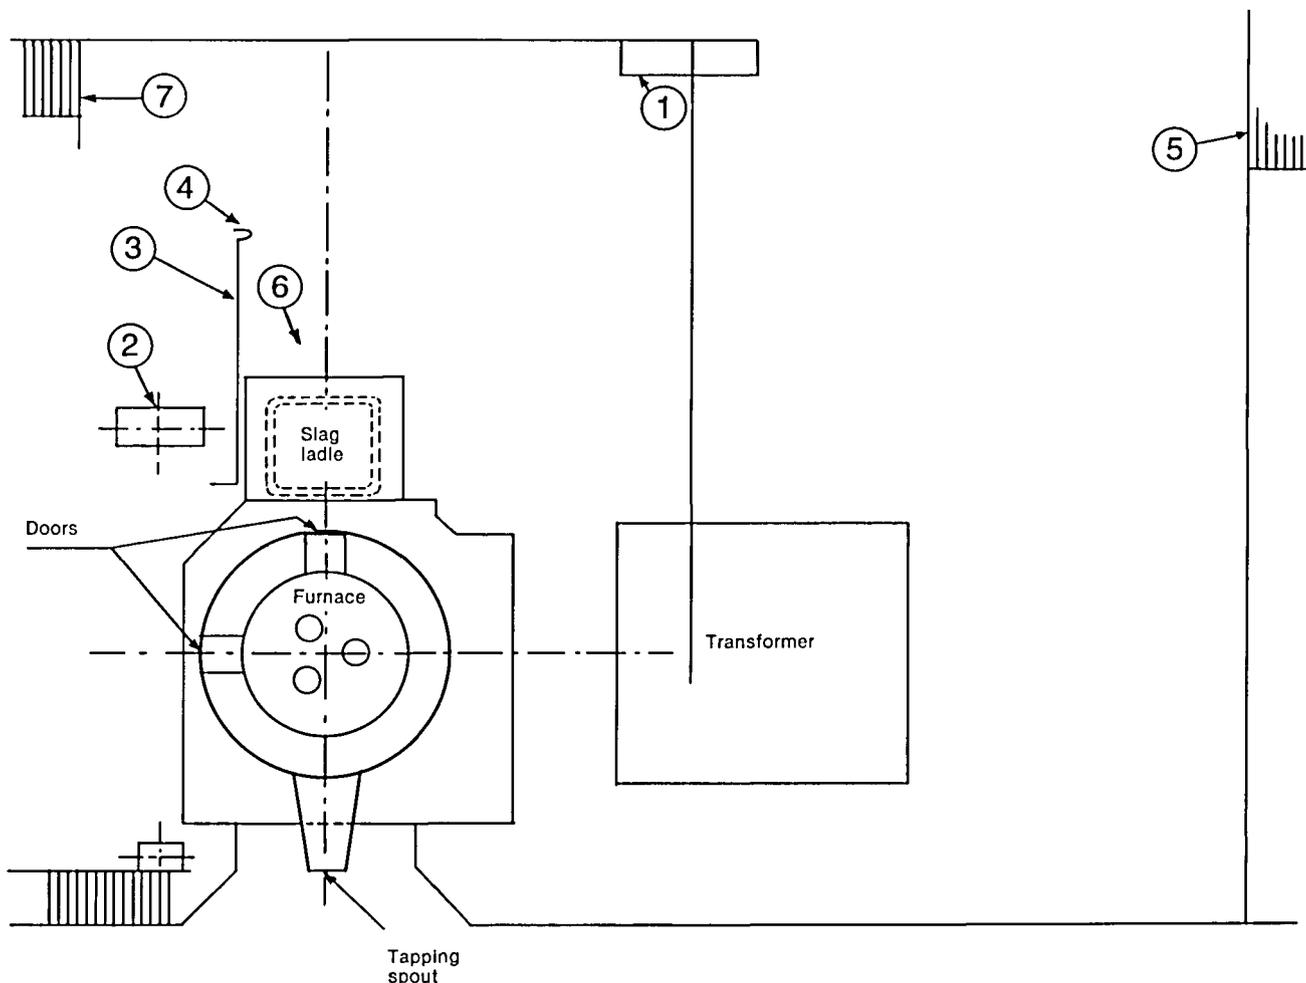
It is assumed that, as soon as the doors were opened, scrap fell into the bath and there was a very violent emission of flame through the open slagging door.

The operative standing at (4) was wearing overall a helmet, goggles, an aluminized jacket/coat and gauntlets. He was burned on the face, on the back of the neck (between the jacket and helmet) and on the shoulder, mainly when the flame was deflected from the wall. He ran towards the access and escape stairs (5), and was intercepted by the foreman, who extinguished his burning clothing. He suffered burns over 4% of his body but no damage to the eyes.

The electrician/crane operator, who was at (6), suffered burns on the front of his body to the face, hands and forearms. He ran towards the access and escape stairs (7), and received assistance on reaching the bottom of these stairs. He suffered second and third-degree burns over 16% of his body, but no damage to the eyes.

- (i) Staff to be reminded of the safety and operating instructions and work on the platform to be organized by the supervisor. 'No personnel to be in the vicinity unless absolutely essential.'
- (ii) Personal protection

The possibility of using a mobile screen with observation slits or mesh has been considered. The necessary design work will be carried out and en-

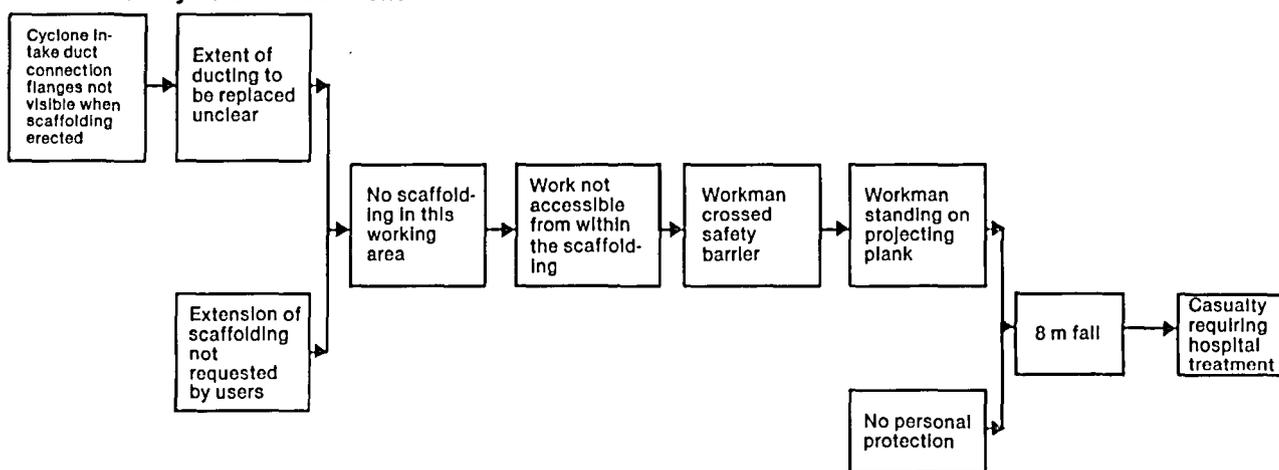
Fault tree analysis of the accident

A workman was engaged in relagging a duct at a height of 40m on an installation. In order to perform his task, the workman crossed the safety barrier of the scaffolding and climbed onto two planks projecting beyond its edge. The planks tipped over and the workman fell a distance of 8m.

- (i) Use of personal protection to be reconsidered.
- (ii) Scaffolding to be suitable for the work to be carried out.
- (iii) Personnel carrying out work at a height to be made aware of the risks involved.
- (iv) Special procedures to be adopted for organizing work sites where scaffolding is used and acceptance to be carried out by the various users of such equipment.

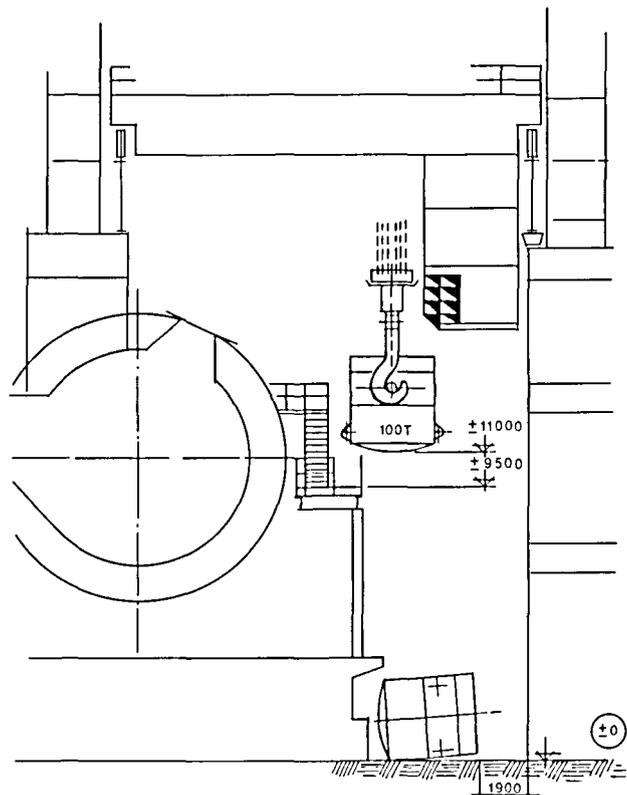
The accident was caused by the fact that one of the lugs was only resting on the point of the hook; this had not been noticed by the crane driver when the hooks were engaged (one side after another) nor by the victim who had been asked by the crane driver if the hook was properly engaged. The victim was standing in a position where he could only see the hook from the back, i.e. edgewise on, and did not notice what had happened.

1. The special directives for engaging lifting gear hooks in the ladle lugs and checks to be carried out are being tightened up.
2. A TV camera to help the crane driver to see objects obscured from view (second lug) is being tested.

3. The possibilities of fitting a device to indicate whether the lugs are fully engaged at the base of the hook (electrical contact load cell, pressure detector, etc.) and to give the crane driver a signal confirming proper engagement is being effected.
4. The shape of the hook point will be modified to increase the opening and facilitate engagement without entailing any loss of strength or risk of disengagement when the ladle is tipped.

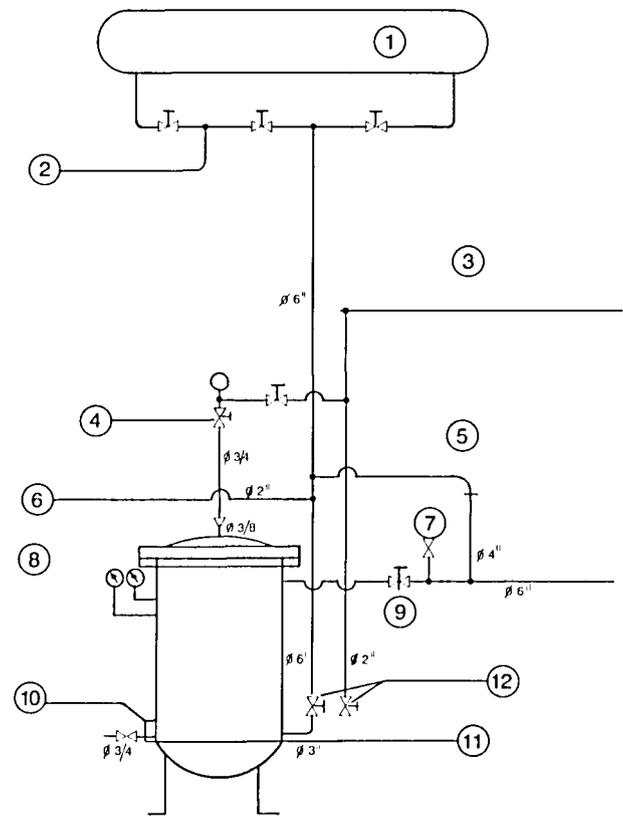
1. Coolant
2. To oil line
3. Discharge pump back to filter
4. Valve open
5. Valve removed — connector to isolate filter from circuit
6. To air/oil pressure tank
7. Pressure gauge
8. Pressure gauges (entry/exit)
9. Valve closed
10. Inspection port
11. Valve open — oil discharged to tank via hose
12. Valves closed

the mechanics was sitting, was then blown off its mountings. The mechanic was gravely injured and died the same day.

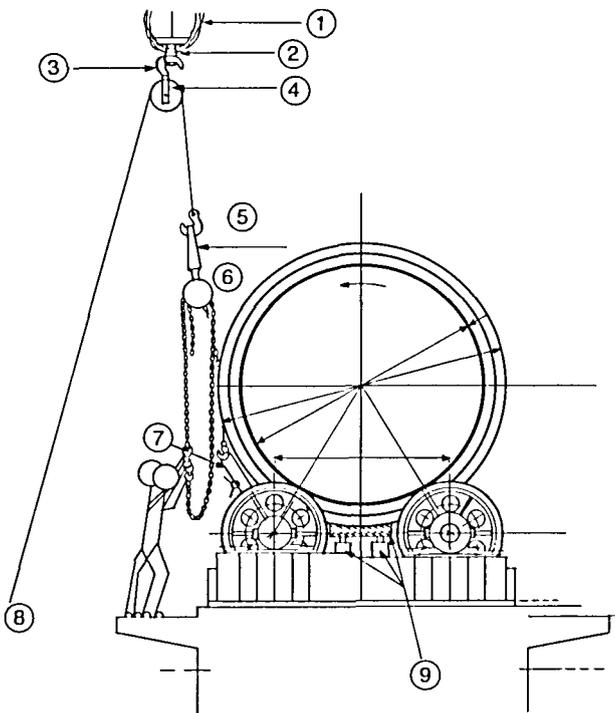
1. Closed sling
2. Coupling link
3. Hook (3t)
4. Return pulley
5. Closed sling
6. Hoist
7. Rope (4 strands)
8. Traction rope
9. Cradle supporting trommel (2 x 50t jacks)

The suspension hook of the return pulley had broken. It was a die-stamped hook on which a rated load of 3t was embossed.
