EUR 3491 e

**THERMOCOUPLE FAILURES IN GRAPHITE
IRRADIATION RIGS FOR BR 2 REACTOR, MOL**

1967

Report prepared at the C.E.N.
Centre d'Etude de l'Energie Nucléaire, Mol-Belgium

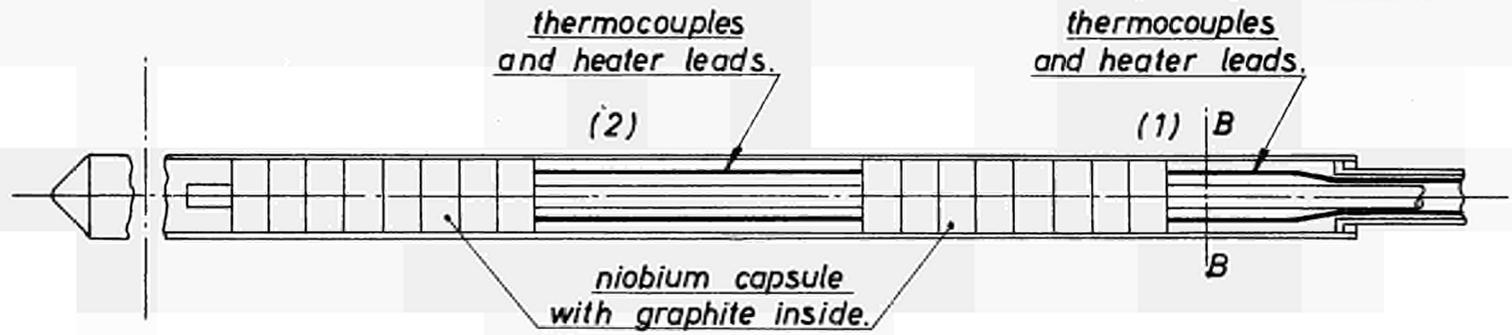
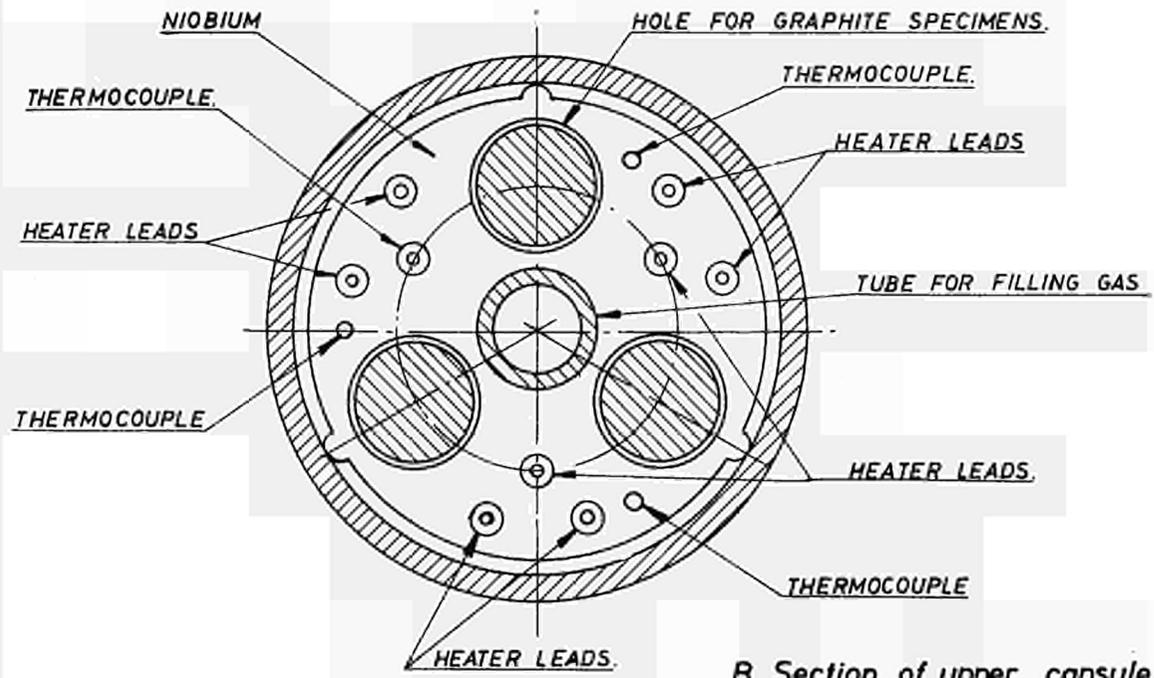
Fig. 1.

- 2.4. The temperature registered during the irradiation period was about 500° C for the bottom capsule and about 600° C for the top capsule, but there is reason to believe that the temperature actually reached about 900° C in both zones (1 and 2) of the rig (fig. 1 A). In figure 1 B the arrangement of thermocouples inside the capsule can be seen.

As mentioned above, this embrittlement was particularly severe in zones 1 and 2 of the rig shown in fig. 1 A.

A. Sketch of the rig showing the position of the capsule and the zones (1) and (2).

B. Section of upper capsule.

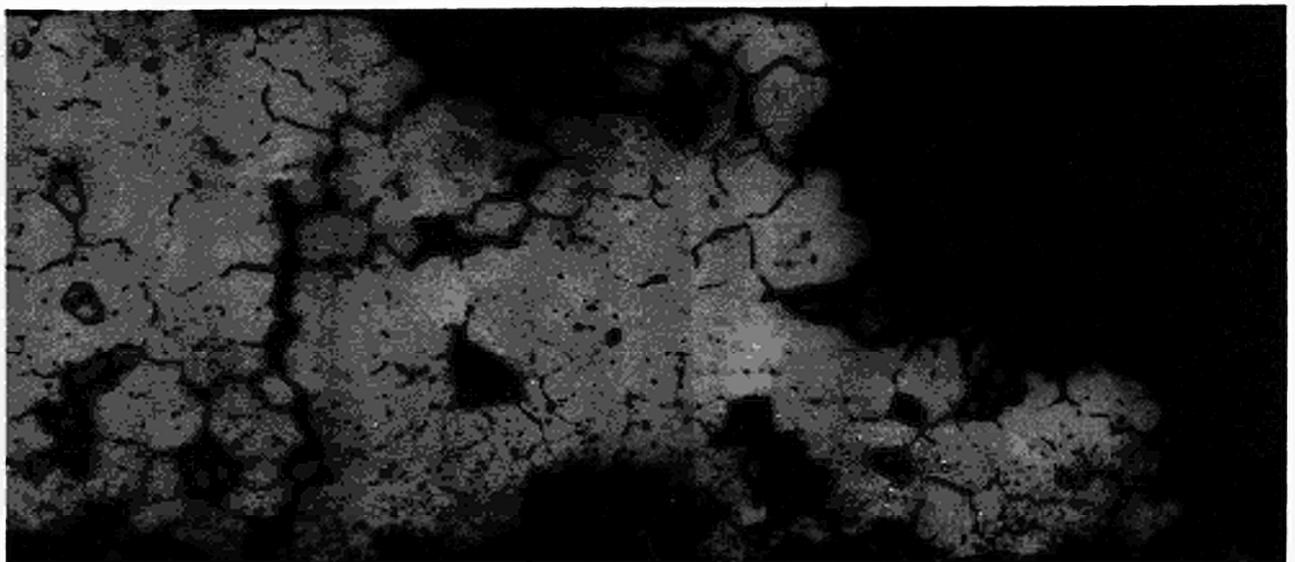
In figure 2 b a large concentration of carbides underlying the external surface of thermocouple sheath can be observed.

The deposition of fine C particles on the external surface of the sheathing tube reduced part of the Cr_2O_3 -rich layer and favoured the carburisation of underlying metal (fig. 2 b).

The factors enumerated above caused a radical change in the nature of the sheath metal (fig. 2 b).

Fig. 2 b - Enlargement of region A. The corrosion has converted the
solid steel into a mass of loosely held grains.

In any case, when graphite is present in the rig the use of 18/8 unstabilized stainless steel as thermocouple sheathing is not advisable, because this type of steel is particularly susceptible to carburisation in the temperature range $650^\circ - 850^\circ \text{C}$ ^(9, 10).

- 6.3. For the particular case discussed the suggestions are as follows:
 - a) Before the construction of the rig and its thermocouples:
 - 1 - a correct choice of material,

- 2 - an acceptance test on this material,
 - 3 - a study of the compatibility of this material with the possible environment in the conditions of the experimental run,

- 4 - a check on the purity of the graphite.
 - b) During the experiment:
 - 1 - use of a higher-purity filling gas,
 - 2 - periodic sampling of the gas during the experiment.

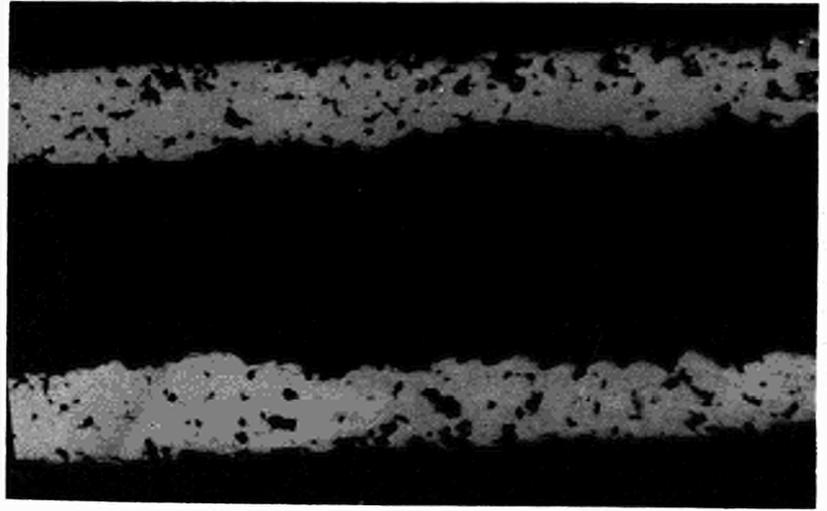
Fig. 3

The photomicrographs in fig. 3 show that the attack on the stainless-steel thermocouple sheath proceeded in two directions.

This photomicrograph of an irradiated thermocouple sheath shows that the intergranular corrosion has occurred on the internal and external surface of the sheathing tube (longitudinal section).

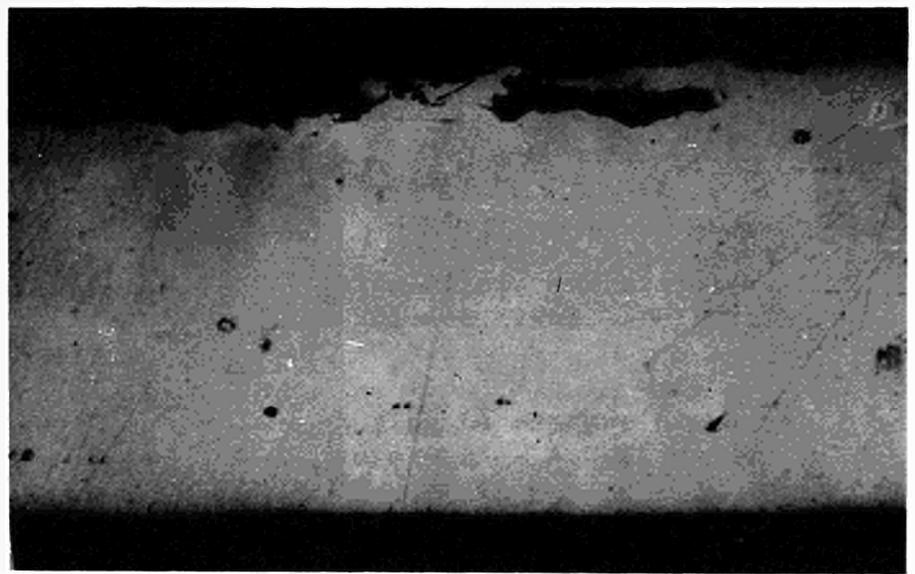
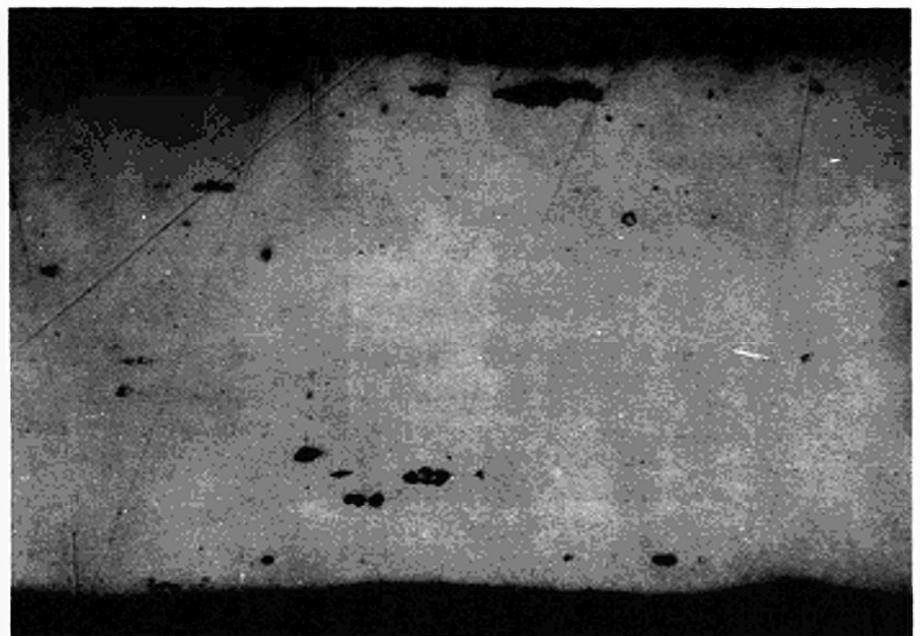
Fig. 4

The external surface condition of the non-irradiated thermocouple sheath was very bad (see top of figs. 4 a, b). At several points the protective oxide layer was certainly very irregular and pitting was apparent (see figs. 4 and 5). On the other hand, the lead content is very harmful to the corrosion-resistance, especially when the stainless steel is subjected to a reactive environment under irradiation effects⁽⁴⁾.

In this case a surface is obtained which consists of internally stressed, disarrayed alloy containing entrained oxide and covered with an oxide formed by preferential oxidation. The photomicrographs in figures 4 a, b (top) show very clearly the bad external surface condition of the non-irradiated thermocouple sheath.

Non-irradiated and unetched stainless-steel thermocouple sheath. These photomicrographs show extensive carbide precipitation. The condition of the external surface (top of the photomicrographs) is very bad. Some pitting and a very irregular appearance are revealed. In the photomicrograph b several inclusions are visible immediately below the external surface.

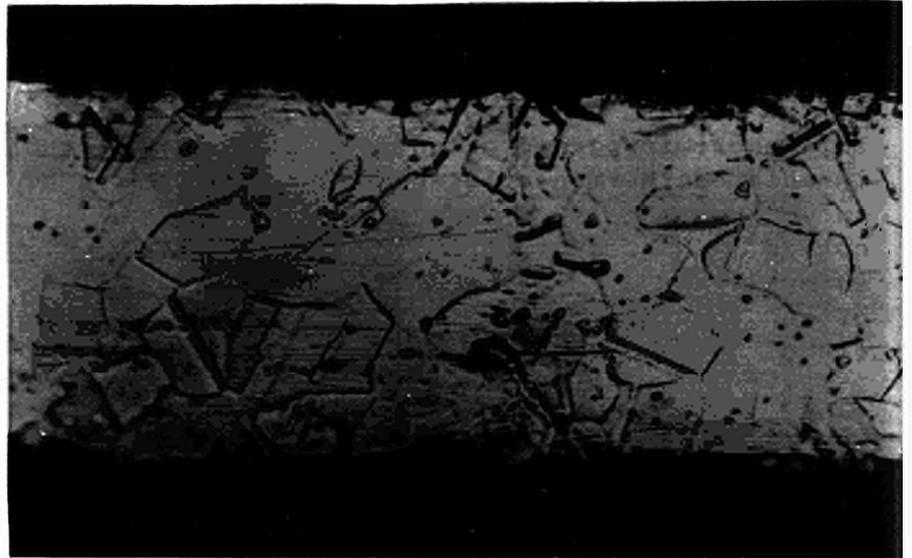
Fig. 5

Longitudinal section of sheath of half-millimetre diameter etched non-irradiated thermocouple sheath. Extensive carbide precipitation and some oxide inclusions can be seen. The appearance of the external surface is very bad (upper surface in photograph).

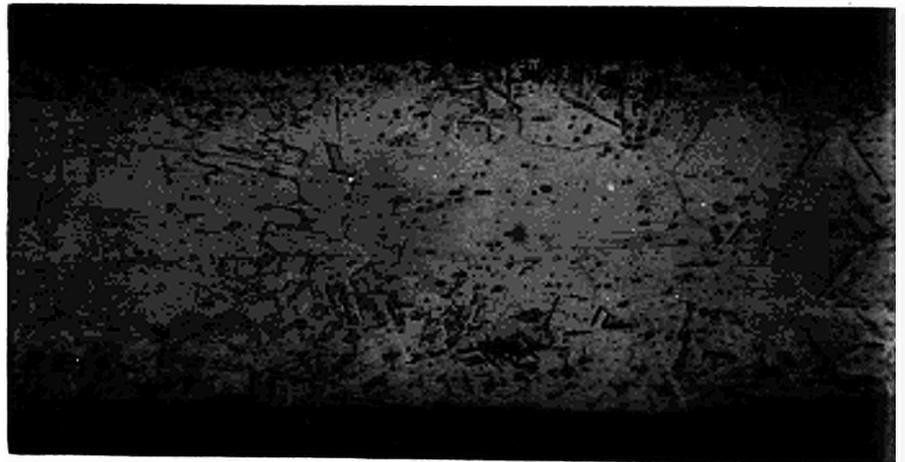
Fig. 6

Longitudinal surface of wall of one-millimetre diameter non-irradiated thermocouple sheath. The photomicrographs show extensive carbide precipitation and several oxide inclusions.
