Support activities for the Directorate-General for Environment, Nuclear Safety and Civil Protection
on the implementation of the Council Directive
on the major accident hazards of certain industrial activities

EC STUDY - LESSONS LEARNT FROM EMERGENCIES AFTER ACCIDENTS IN DENMARK INVOLVING DANGEROUS SUBSTANCES

C.D. Grønberg, L. Smith-Hansen, D.S. Nielsen

EUR 15562 EN

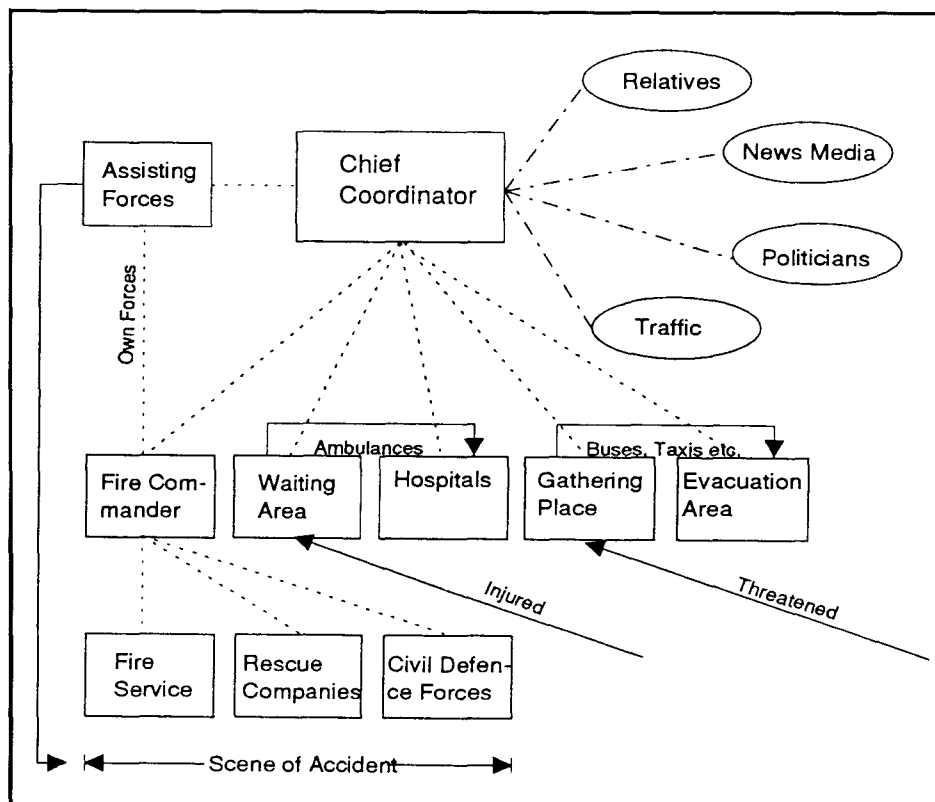
Figure 1 shows the structure of the Danish emergency organization in case of a major accident. When emergency actions imply the use of command centres and involves such things as large-scale evacuations, coordination with several hospitals, etc. the command structure is as follows:

Figure 1. Structure of emergency organization for a major accident
